HUDSON MOTOR CAR COMPANY

TECHNICAL SERVICE BULLETINS

TS 77-1 – TS 84-2

TECHNICAL BULLETIN INDEX - Volume I

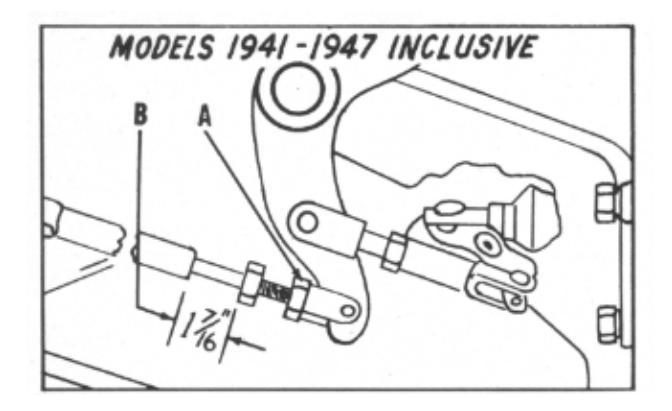
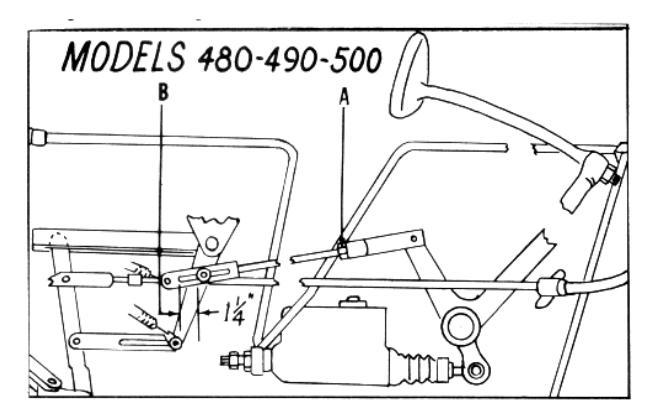
It will be noted that the adjustment for mechanical brake engagement shown in the sketches above differs somewhat due mainly to the change in design of various models. Adjust at "A" to obtain clearance at "B".

When the brakes are relined or taken up (at which time the hand brake should always be reset) the mechanical safety follow up clearance should he carefully chocked and the necessary correction made very accurately, When the clearance at the point of "take up" as shown in the following sketches is accurately made and should the hydraulic brakes fail for any reason the mechanical brakes will function in a normal manner as the brake pedal movement and pressure are continued downward.

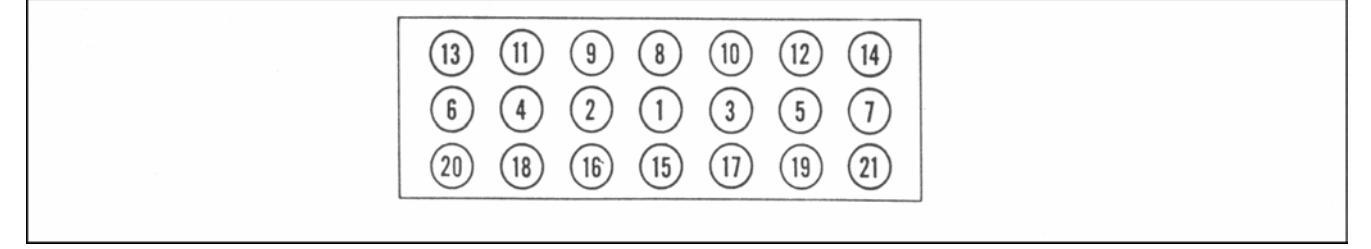
Illustrated below is an order of tightening. The initial tightening should be very gradual, going over all cap bolts three or four times until the torque wrench indicates a uniformity of 75 to 80 foot pounds.

Engine should be idled slowly until it reaches normal operating temperature when all cap bolts should be retightened to 75 to 80 foot pounds. Run engine again until it reaches normal operating temperature-this time allow it to cool - and again torque all cap bolts to 75 to 80 foot pounds in the order shown in the illustration.

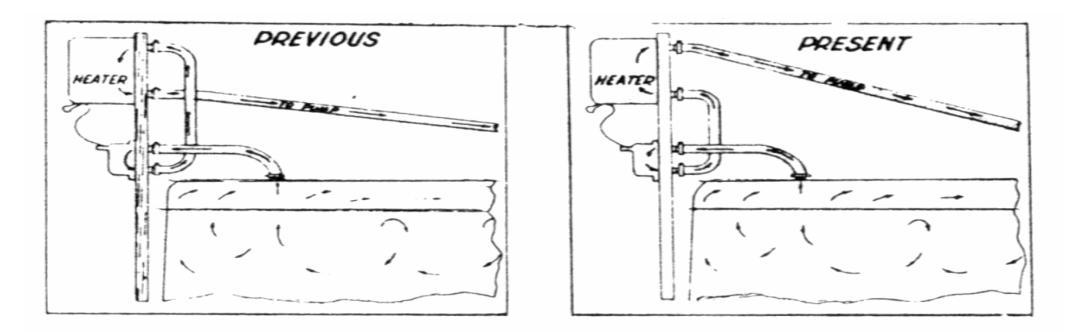
With this new core, the inlet hose (from Ranco valve) must be connected to the LOWER heater core tube and the outlet hose (to the water pump) to the UPPER tube. This is just the reverse of the manner of connecting to the former heater core. Shown in the illustration below are the former and present methods of connections.

The air vent has been eliminated from, the new heater core upper tank and it is therefore very important that connections be made correctly to avoid possibility of air trap resulting in impaired heating efficiency,

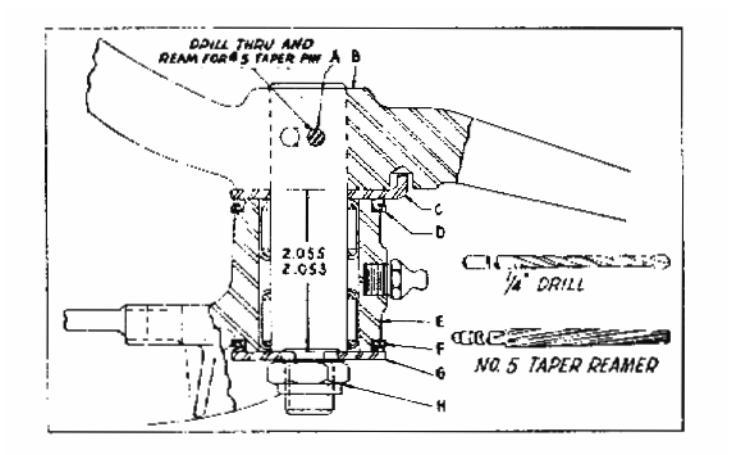
The pivot pin is a press fit in the center steering arm, secured by a No. 5 taper pin. The cross section of the center steering arm pivot pin and support bracket, illustrated below.

When them is occasion for replacing center steering arm or pivot pin, disconnect tie rod ends, unbolt and remove center am pivot support bracket. Remove nut "H" shown in illustration and take out steering am and pivot assembly. Drive cut taper pin and press pivot pip. out of steering am.

The pivot pin is not drilled because it is much easier to drill it in position than to try to maintain the dimension, as -shown in the illustration, and, at the some time, have the holes coincide.

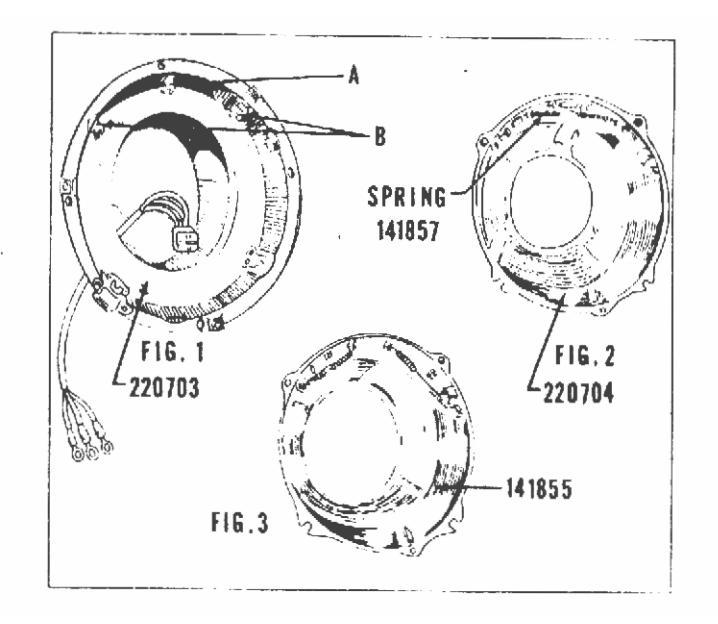
Headlamp Housing Assembly, #220703, as shown in Figure #1, may be used as a replacement Housing for all Models from 1940 through 1954.

When used as a replacement on models prior to 1948, Clips "B" in illustration Figure #1, are used to engage the retaining springs of Mounting Ring #141855, Figure #3, used on all Models 1940 through 1947.

Mounting Ring, #220704, Figure #2 is used on all Models from 1950 through 1954 and uses a single retaining spring, retained by Clip "A" in the Headlamp Housing Figure #1.

Mounting Ring, #220704, may also be used as a replacement for #141855 on earlier Models, by the addition of a Retaining Spring, #141857, the springs then being relocated the same as shown in Figure #3, as provided for on the new Mounting Ring.

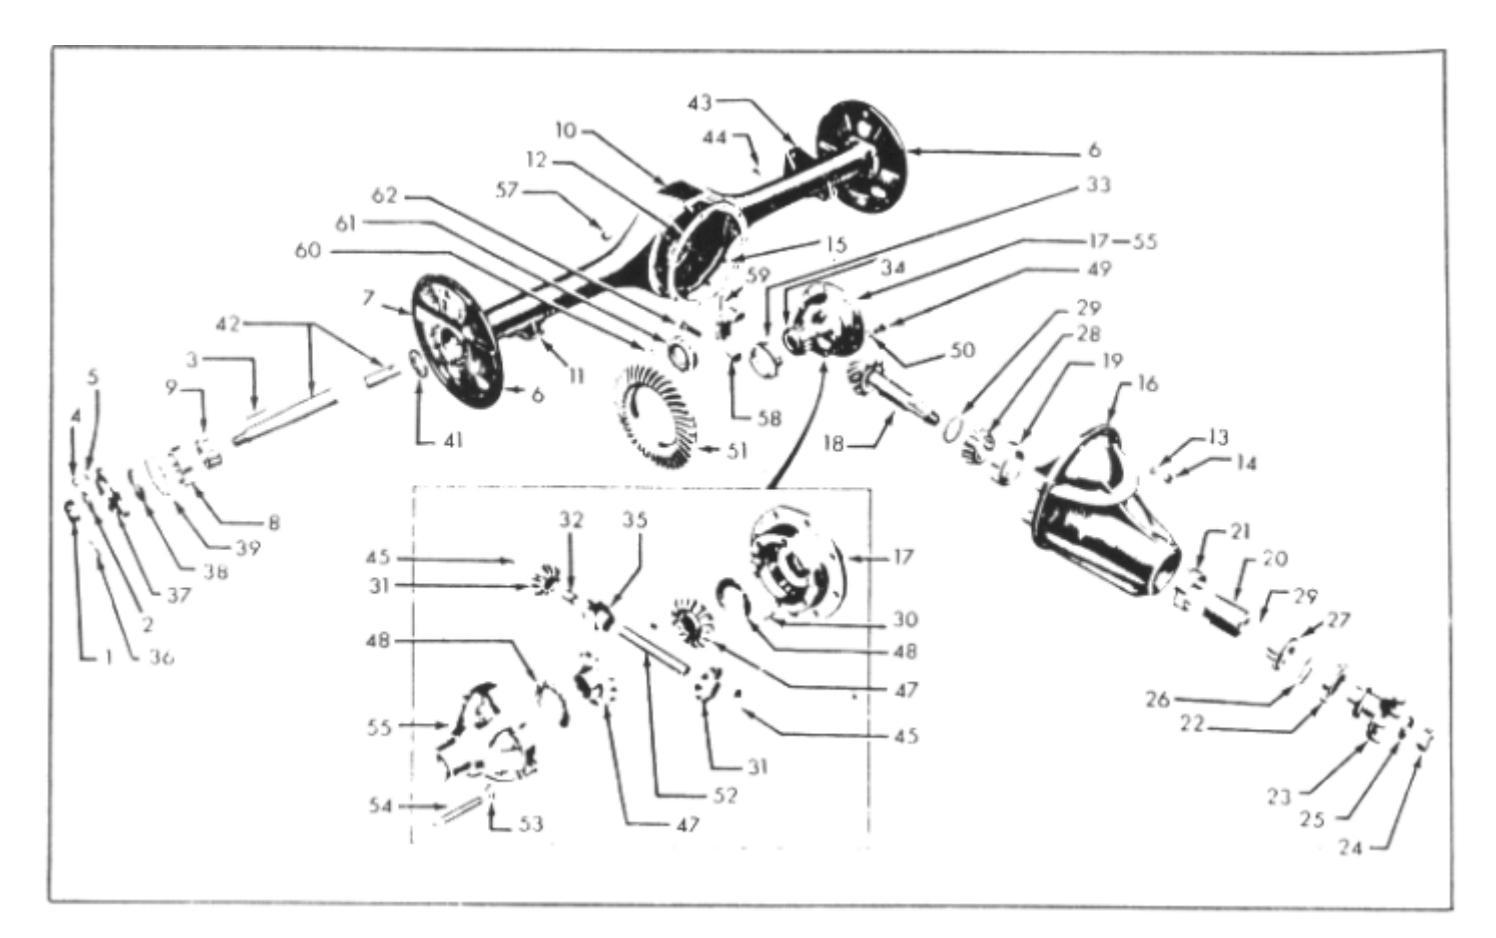
FIGURE 1

- 1. Drive shaft nut
- 2. Drive shaft nut washer
- 3. Drive shaft key
- 4. Adjusting cap bolt nut
- 5. Adjusting cap bolt nut lockwashers
- 6. Brake backing plate
- 7. Adjusting cap bolt
- 8. Wheel bearing cup
- 9. Wheel bearing cone
- 10. Axle housing
- 11. Spring mounting pad
- 12. Differential carrier gasket
- 13. Differential carrier to housing bolt lock washer
- 14. Differential carrier to housing bolt nut
- 15. Differential carrier to housing bolt

- 16. Differential carrier to cap assembly
- 17. Differential case left half
- 18. Drive pinion
- 19. Rear pinion bearing cup
- 20. Pinion bearing spacer
- 21. Front pinion bearing cup
- 22. Pinion oil seal
- 23. Rear axle companion flange
- 24. Rear axle companion flange nut
- 25. Rear axle companion flange washer
- 26. Drive pinion oil washer
- 27. Front pinion bearing cone
- 28. Rear pinion bearing cone
- 29. Rear pinion bearing shim
- 30. Differential pinion shaft locating screw

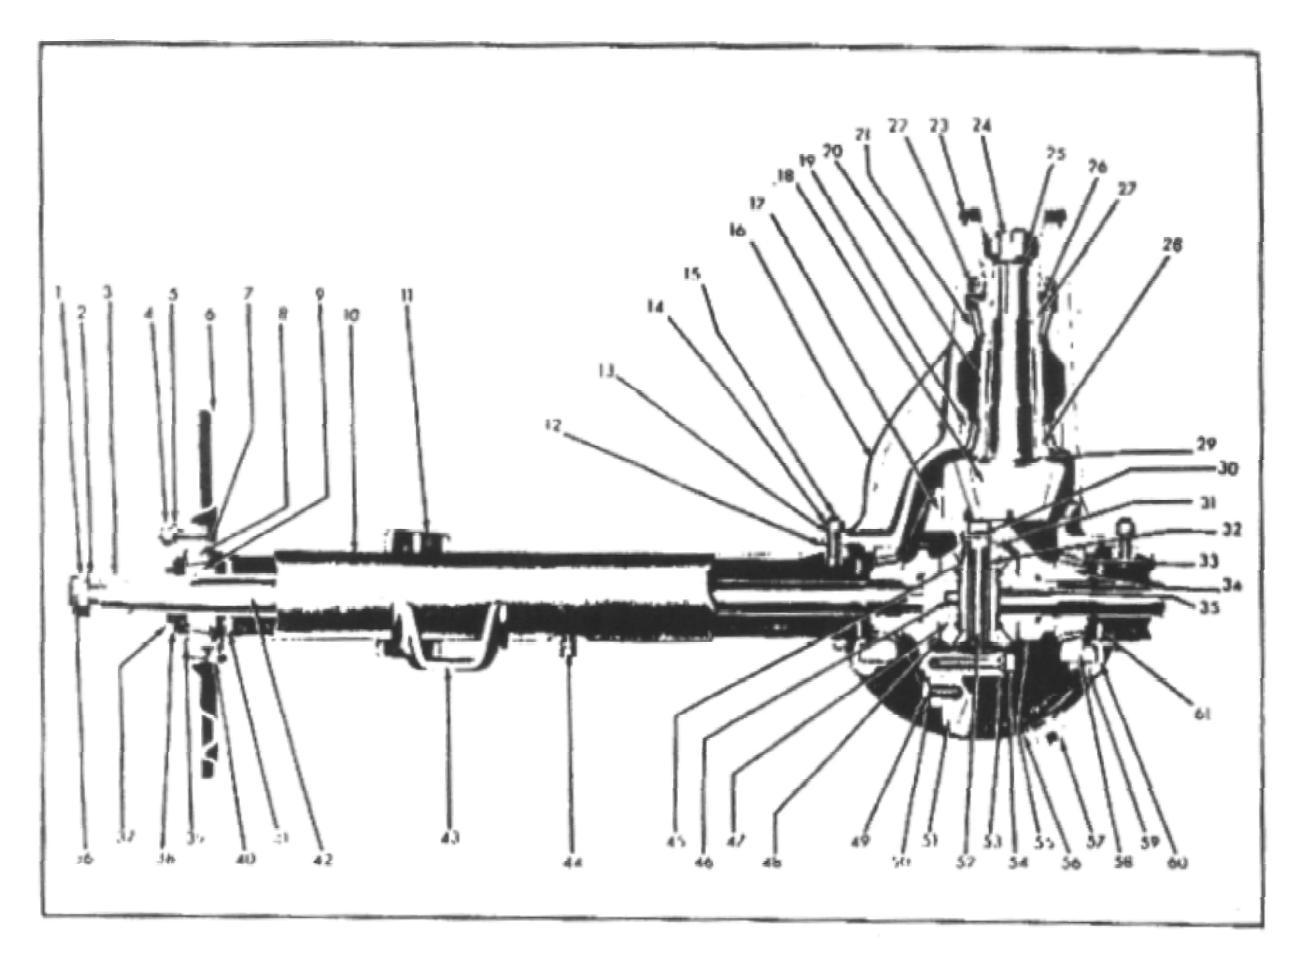
FIGURE 2

- 31. Differential pinion assembly
- 32. Differential pinion bushing
- 33. Differential bearing cup
- 34. Differential bearing cone
- 35. Drive shaft thrust spacer
- 36. Drive shaft nut cotter
- 37. Wheel bearing adjusting cap
- 38. Wheel bearing adjusting cap oil seal
- 39. Wheel bearing adjusting cap shims
- 40. Wheel bearing grease hole plug
- 41. Drive shaft oil seal assembly
- 42. Drive, shaft
- 43. Rear axle housing stabilizer bracket cotter
- 44. Rear axle housing vent assembly
- 45. Differential pinion thrust washer
- 46. Drive shaft thrust button
- 47. Differential gear

- 48. Differential gear thrust washer
- 49. Drive gear bolt
- 50. Drive gear bolt lockwasher
- 51. Drive gear
- 52, Differential pinion shaft
- 53. Differential care screw lockwasher
- 54. Differential case screw
- 55. Differential case right half
- 56. Housing cover
- 57. Housing cover drain plug
- 58. Differential bearing adjusting cap
- 59. Differential bearing adjusting nut lock
- 60. Differential bearing adjusting nut lock
- 61. Differential bearing adjusting nut
- 62. Differential bearing adjusting cap screw

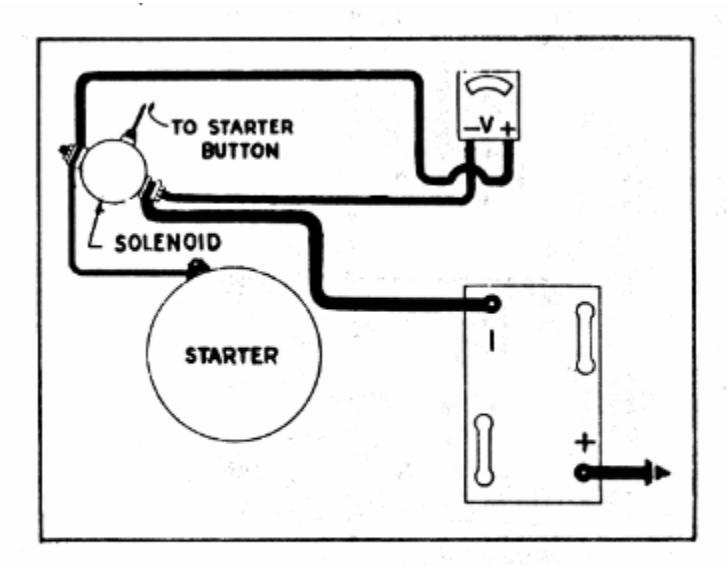
1. Connect the negative lead of a voltmeter to battery terminal of starter solenoid switch and the positive lead to the starting motor terminal of the starter solenoid switch, as shown in the illustration (typical 1951-54).

2. Close the solenoid electrically to crank the engine; if the reading is more than 0.2 volts, replace the solenoid switch.

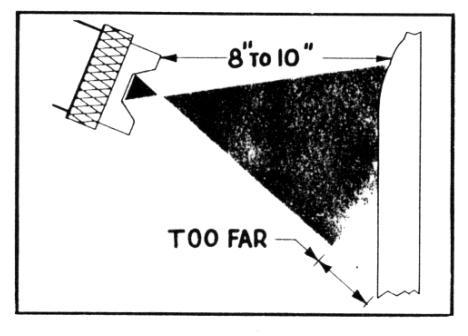
From what has been said above it is obvious that if the gun is tilted toward the surface so that the fan pattern is not uniform or if the gun is swung in an arc from right to left varying the distance from the

nozzle to the work, much trouble will ensue.

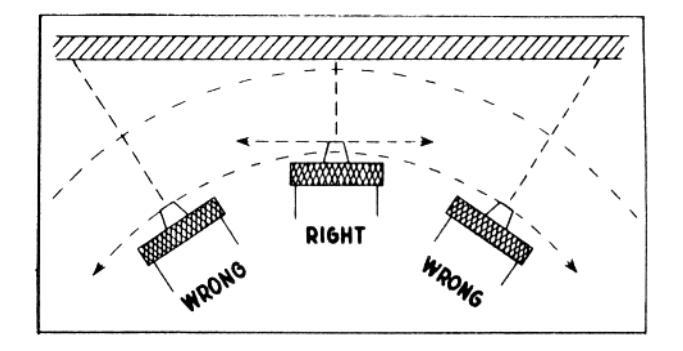
The gun should be at right angles to the job in all directions and at all times. In other words do not fan the gun from left to right or do not have any up and down wrist motions if you want a uniform film.

The only time that it is permissible to fan the gun at all is on a small spot spray where you want the edges of the spot to be thinner than the center portion and even then the fanning operation should be kept at a minimum. On large surfaces where it is necessary to use many strokes to cover the area always work to a wet edge by using a fifty percent overlap and direct the center of the spray fan at the lower or nearest edge of the previous stroke. To summarize what we have said above you will get better, smoother jobs if you:
